FIVE ISLANDS WHARF STUDY,

GEORGETOWN, MAINE /

June 7, 1990

**CONDITION SURVEY  
FIVE ISLANDS WHARF  
GEORGETOWN, MAINE**

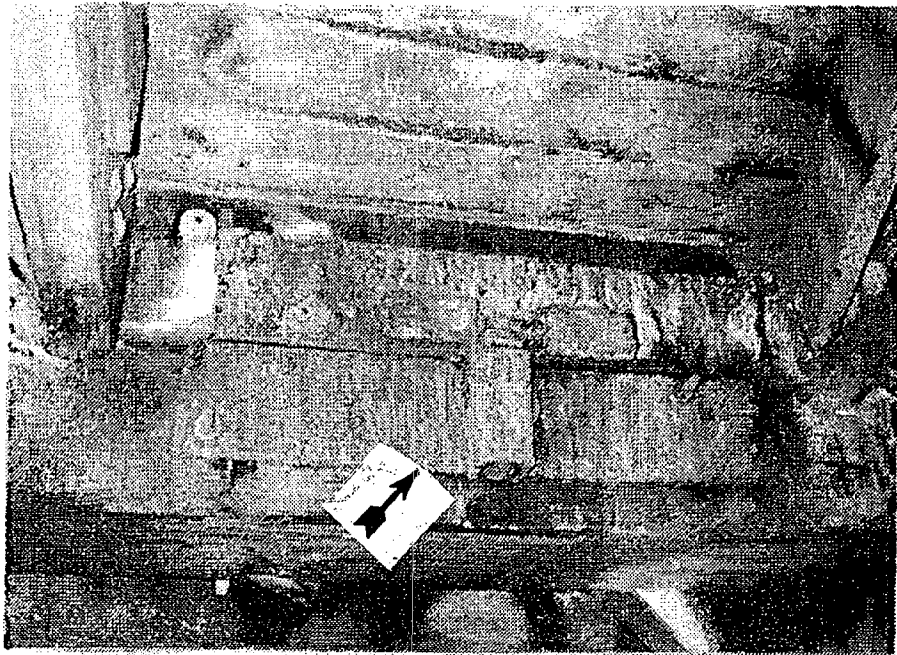
A

rusted hinge under float ramp badly in need of repair.

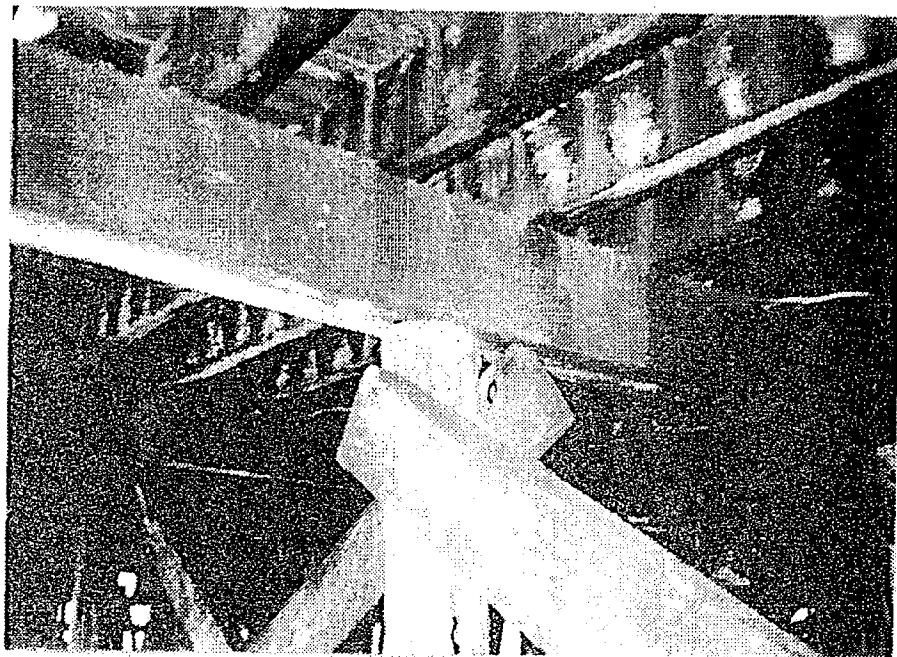
B

Typ. pile, beam and rafter.

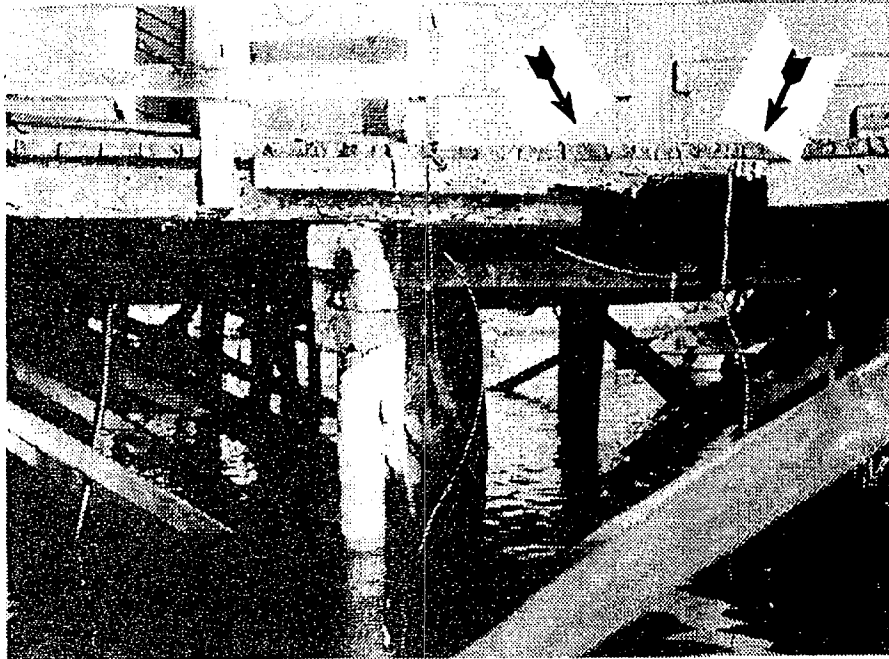
A

All members of the wharf, including the deck support timbers, piles and cross bracing were tested for structural integrity. Ice pick penetrations ranged from  $1/2$  to 1 inch in the deck,  $1/2$  to 2 inches in the support timbers, and  $1/4$  to  $5/8$  inches in the piles and cross bracing. Moist conditions and rot were evident under the decking and under some of the support timber, particularly toward the south side.

South end of dock showing rotting of decking and beams.

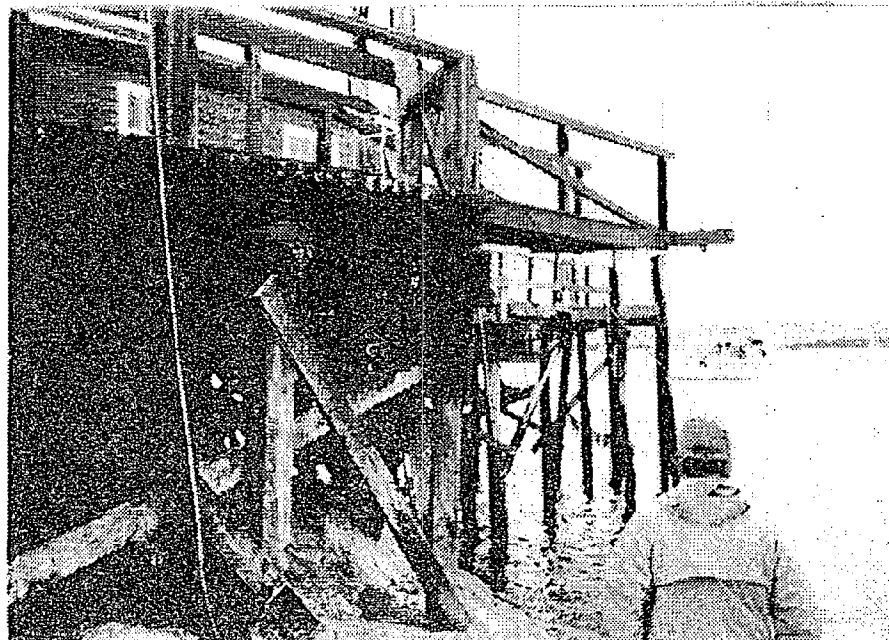
B

Overall view of south end of dock.

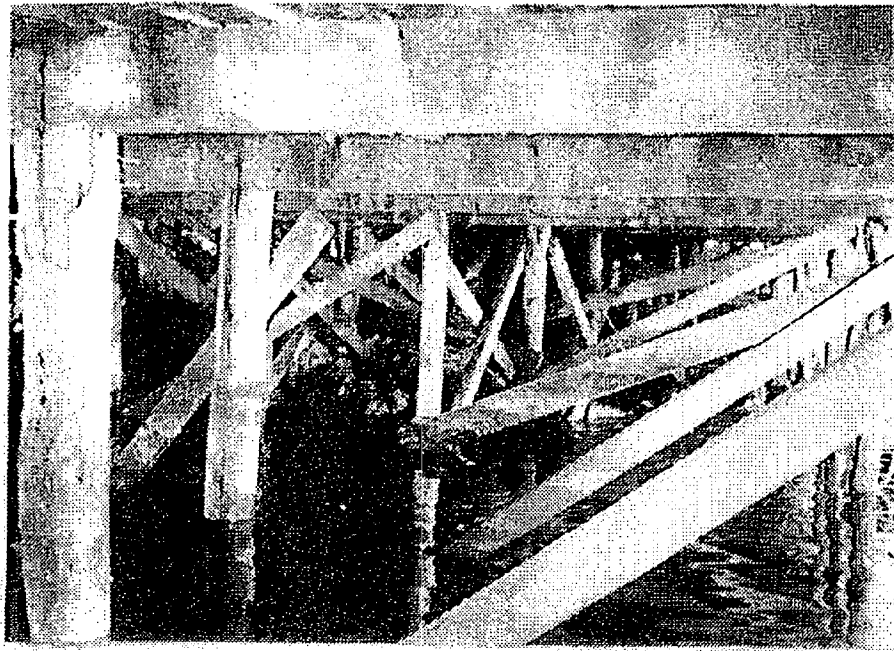
A

Typ. piles and cross members.

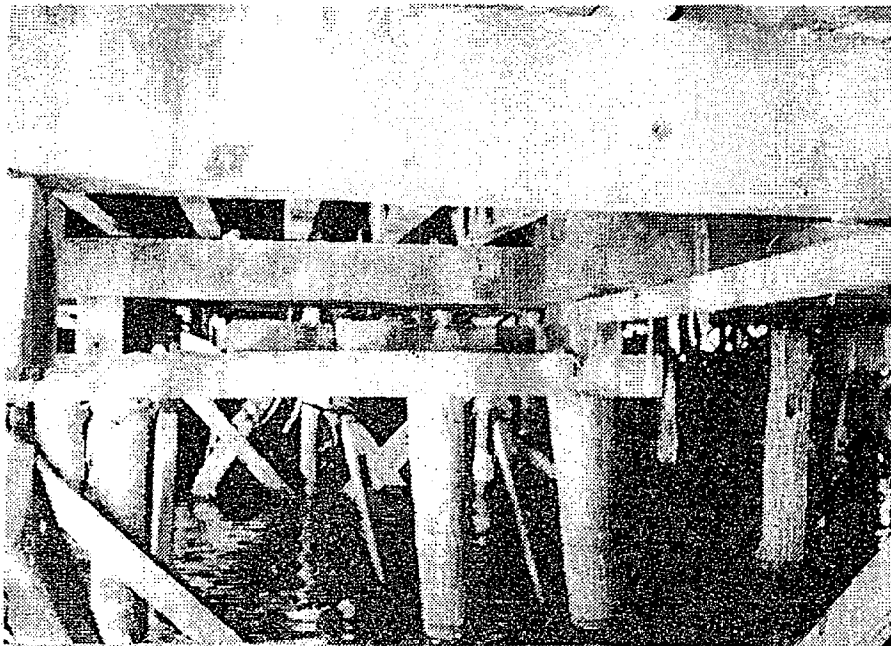
B

- 3) The support timbers under the decking are arranged in an orderly fashion, except for those under the south side, and those next to the Cooker/Cooler building. Wooden blocking has been used to achieve the correct support height over some of the shorter piles.

Typ. cross beam design, built to get desired elevation.

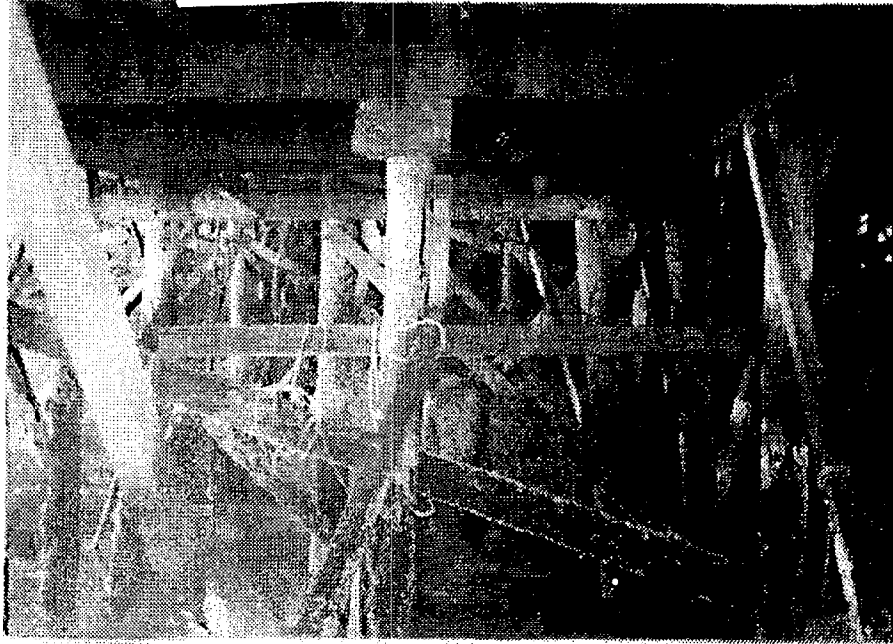
Typ. piles and cross bracing towards front of dock.

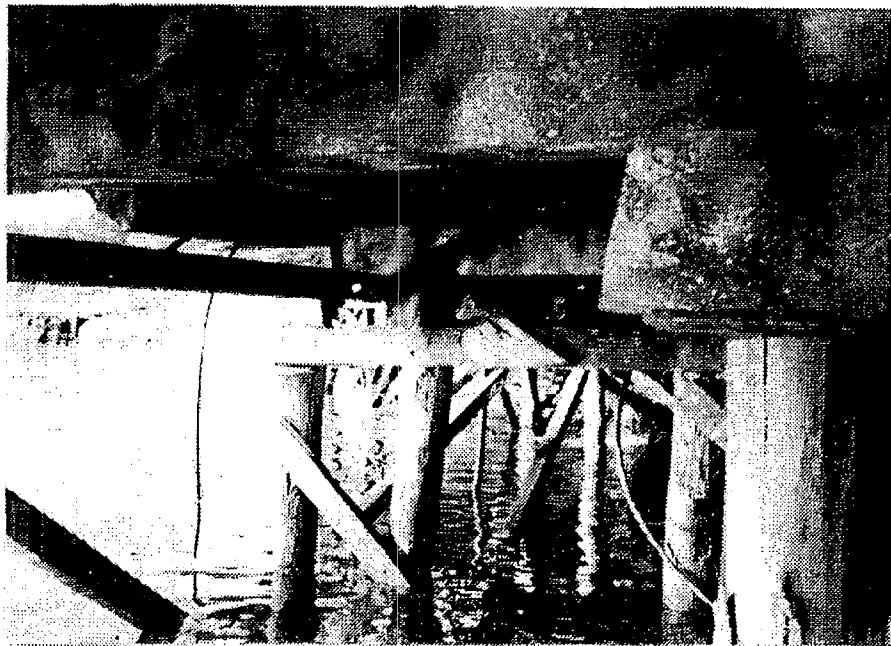
B

Typ. blocking used for elevation desired.

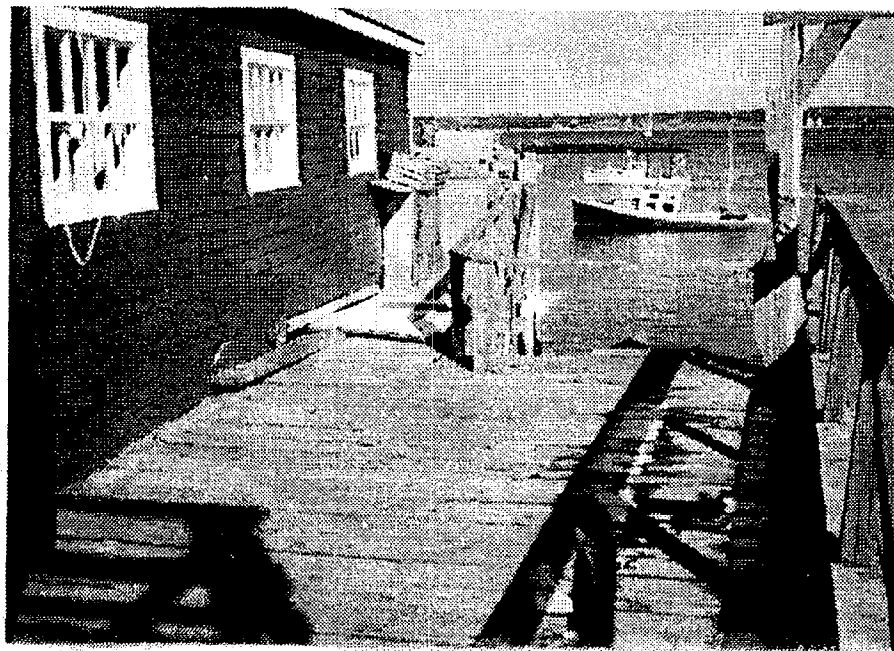
- 1) The wharf, which was reconstructed in 1978, is in moderately good condition.
- 2) The wharf decking has been partially replaced with new decking since 1978. Much of the remaining deck will require replacement over the next five years.

Deteriorated decking out by town float.

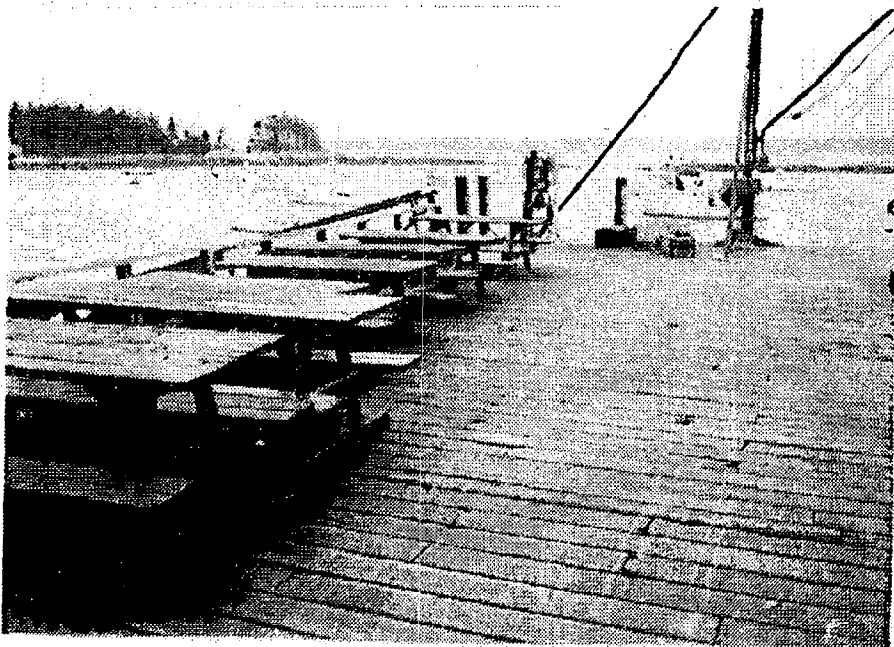
Photo showing decking towards front of dock.

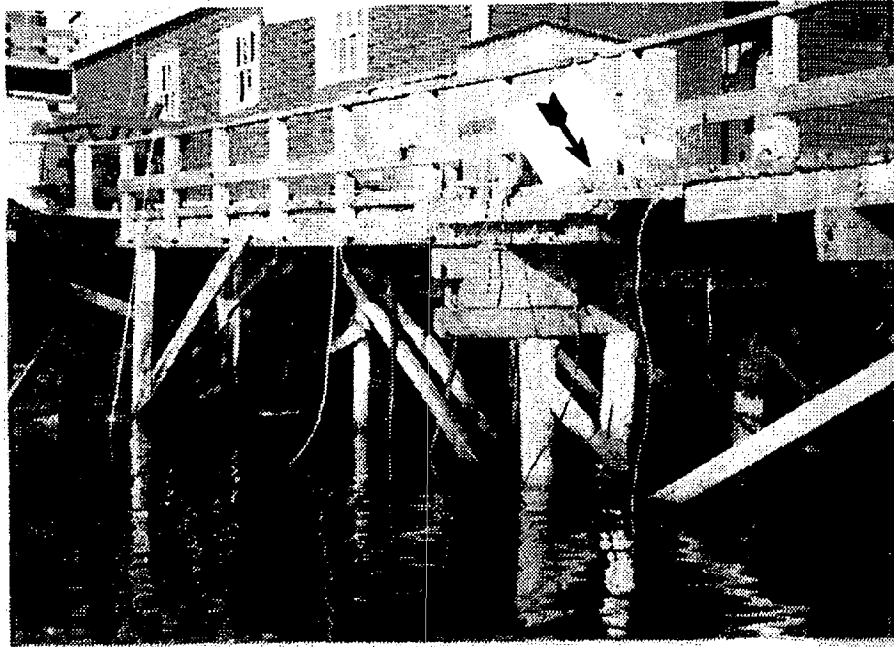
A

Severe rotting of beam at south end of dock.

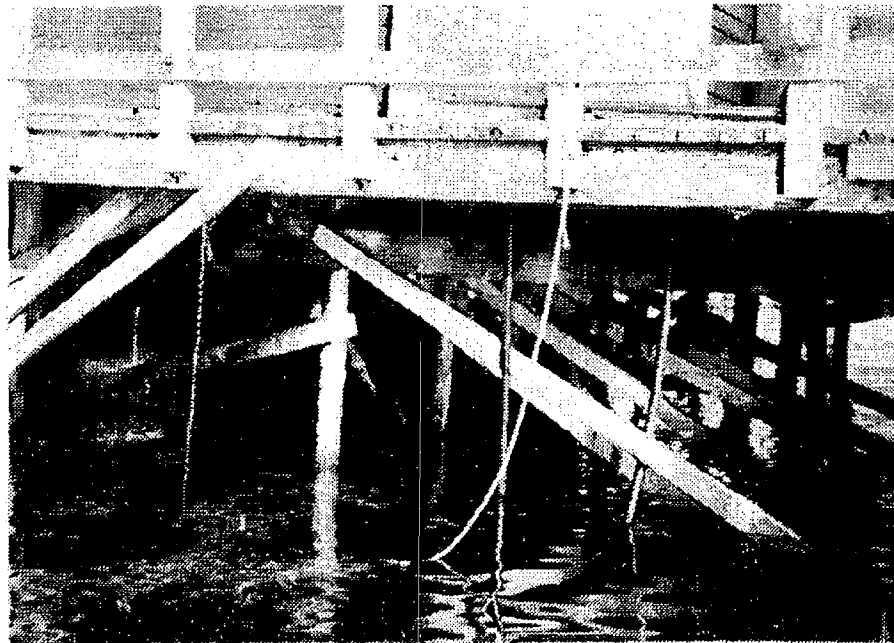
B

- 8) The Shrimp Building, which was built in 1970, is in good condition and is comprised of a concrete floor. The reinforcing arrangement in the concrete floor is unknown. Floor drains located at convenient spots within the floor discharge directly on to many of the piles and cross members. The electrical wiring system beneath the building does not comply with existing codes.

South end of dock showing pipes and wires not to standard codes.

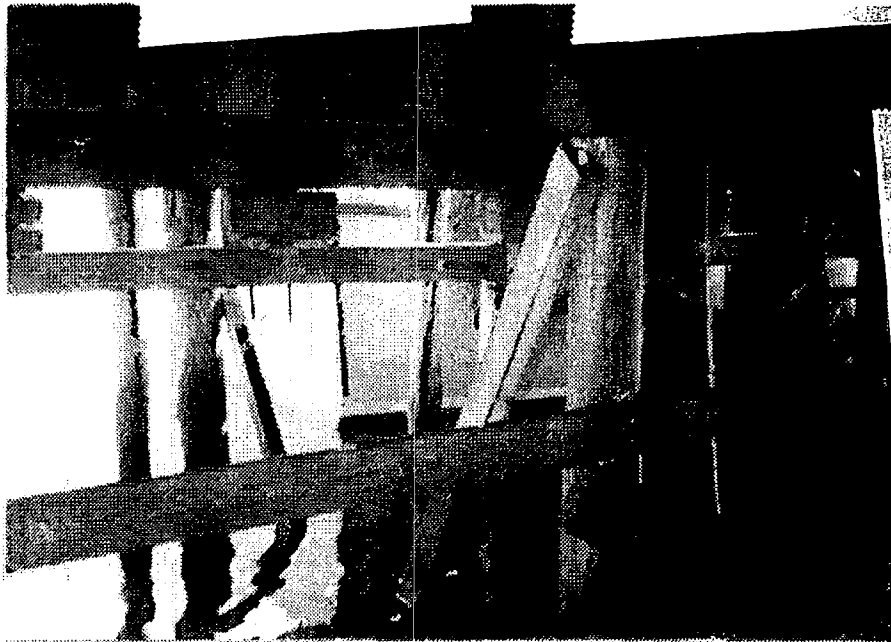
A

Typ. cross bracing towards front of dock.

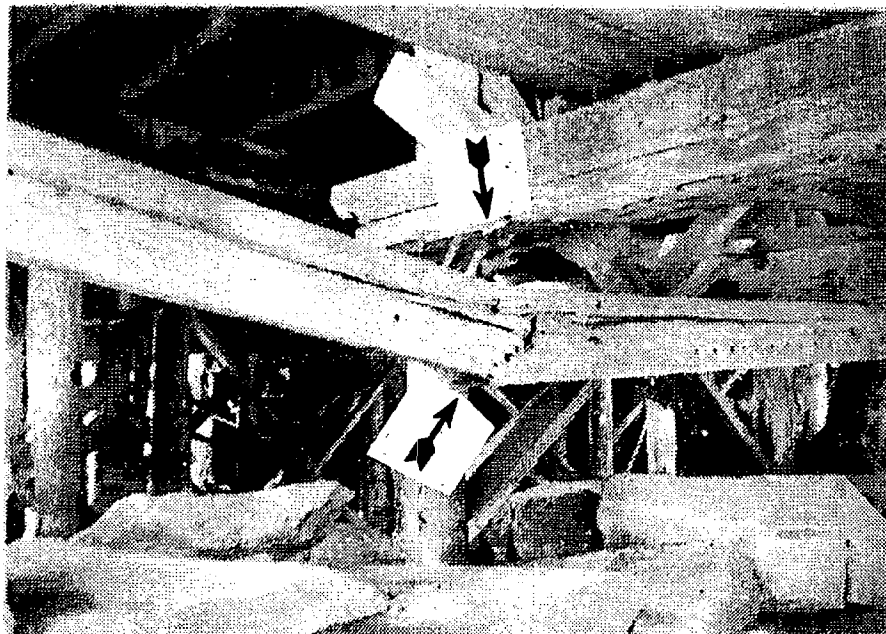
B

Typ. failed beams on lower deck from above, north of Cooker.

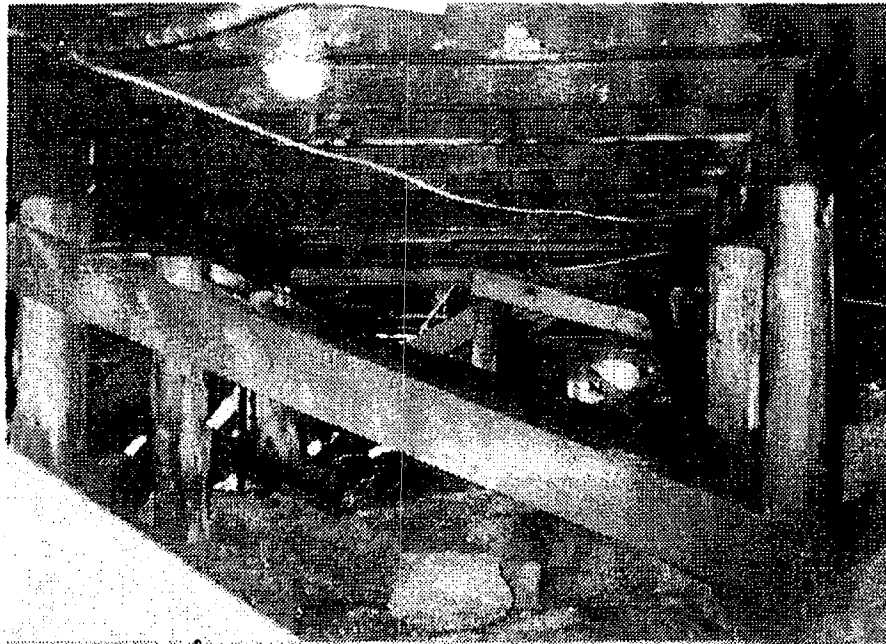
A

Typ. cross bracing, under Cook house.

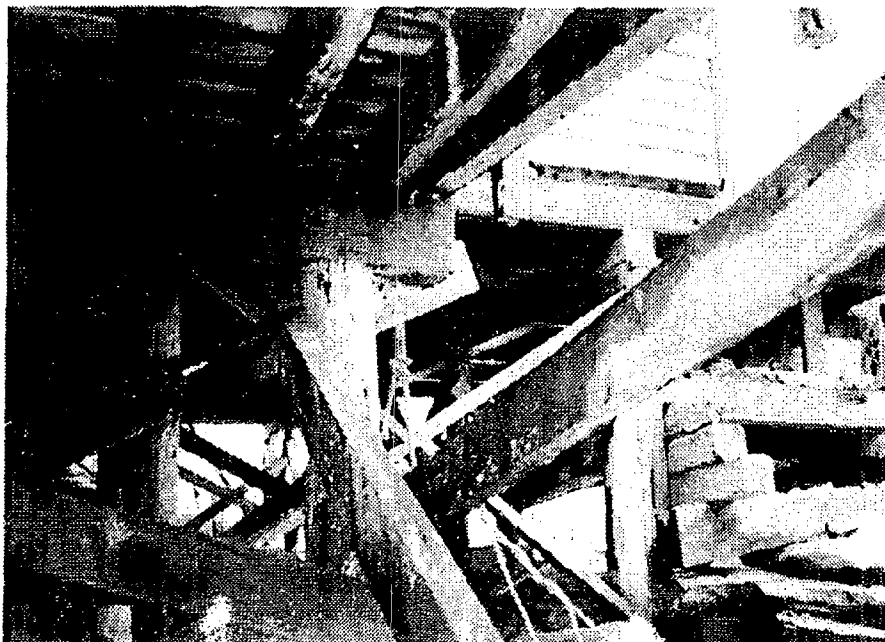
B

North end of dock looking towards Cook house.

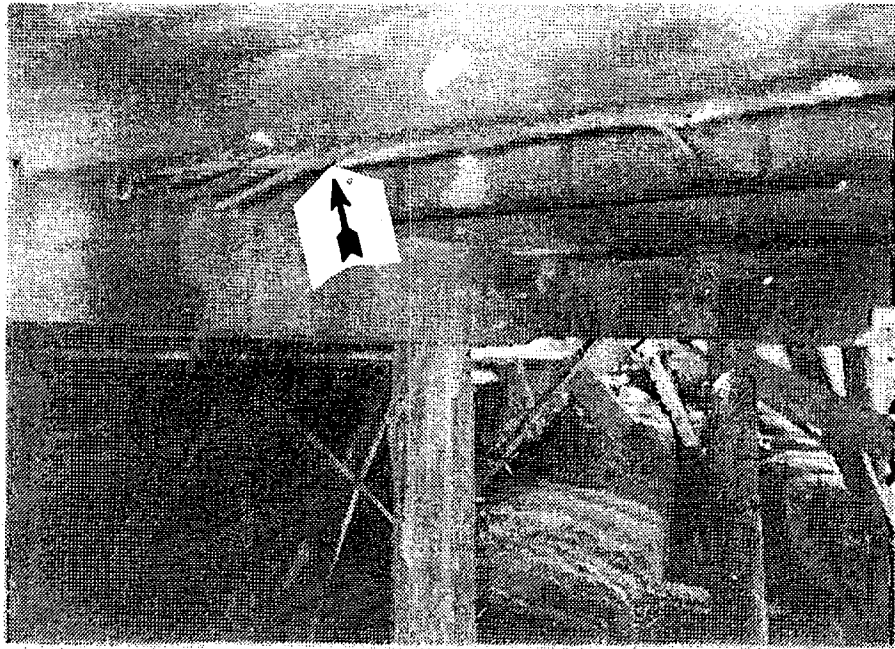
Typ. photo showing rotting rafters under Cook house.

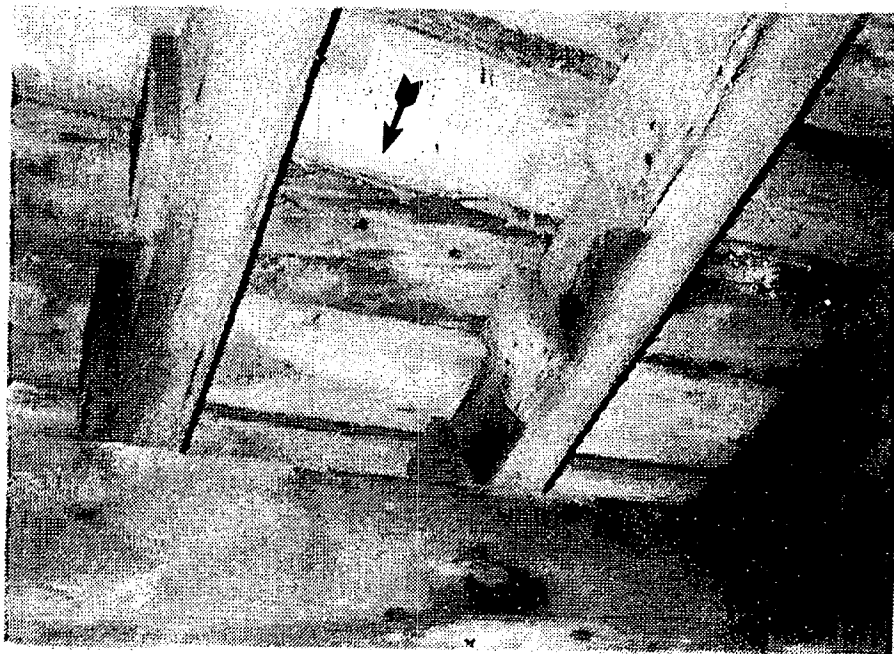
Typ. rotting decking and beams.

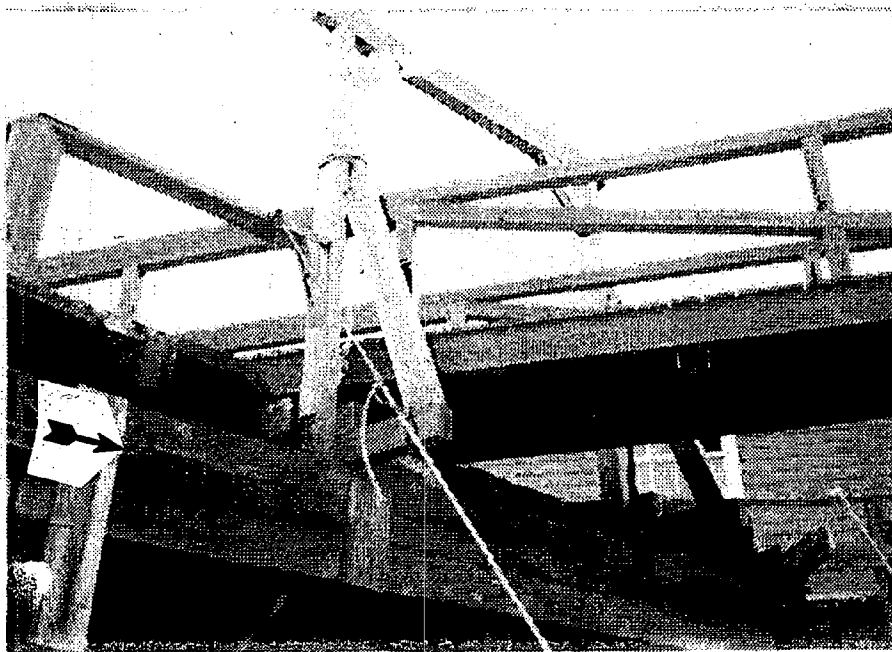
Town float, some beams showing signs of decay.

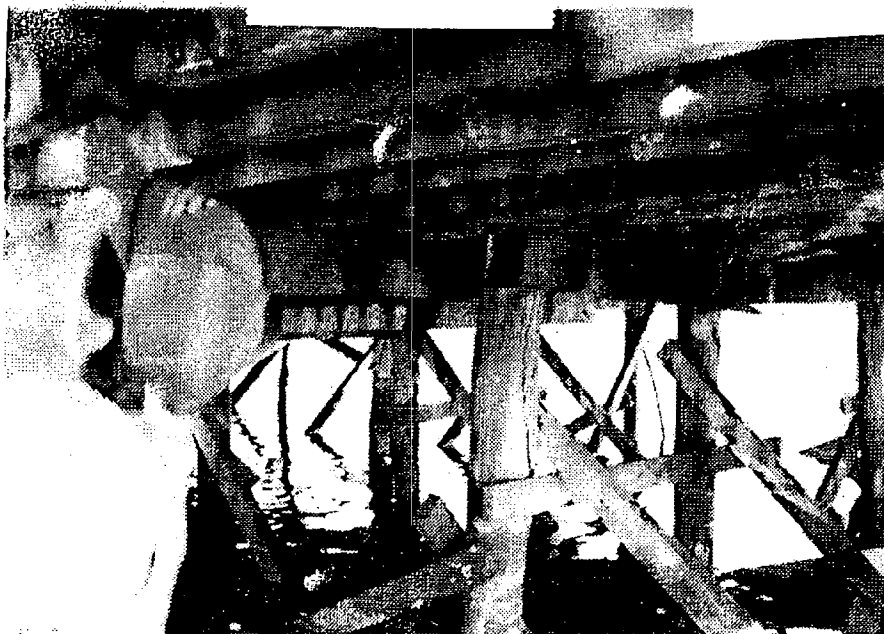
Checking for rot at rafter.
